M.S. Thesis

2019

SEISMIC BEHAVIOR OF AN ORDINARY RC STRUCTURE
EXPOSED TO CORROSION

IŞIK UNIVERSITY

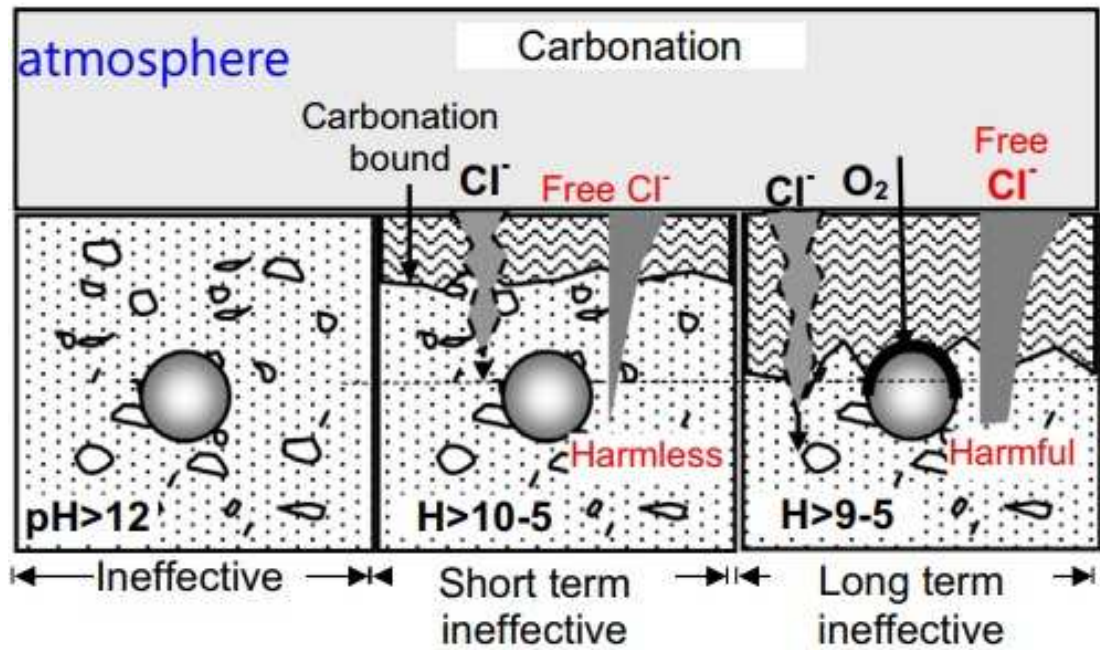
Normally, concrete provides high alkalinity to the reinforcing steel bars and concrete carbonation that is chemical deterioration of the concrete surface is the most critical agent that reduces pH value of the concrete. Ingress of carbon dioxide from the atmosphere may decrease pH value to 9 and passivation feature of concrete on steel bar can be lost and depending on the factors such as humidity and oxygen, corrosion may occur (Dogan (2015) [2]).

Figure 2.2: Carbonation (Dogan (2015) [2])

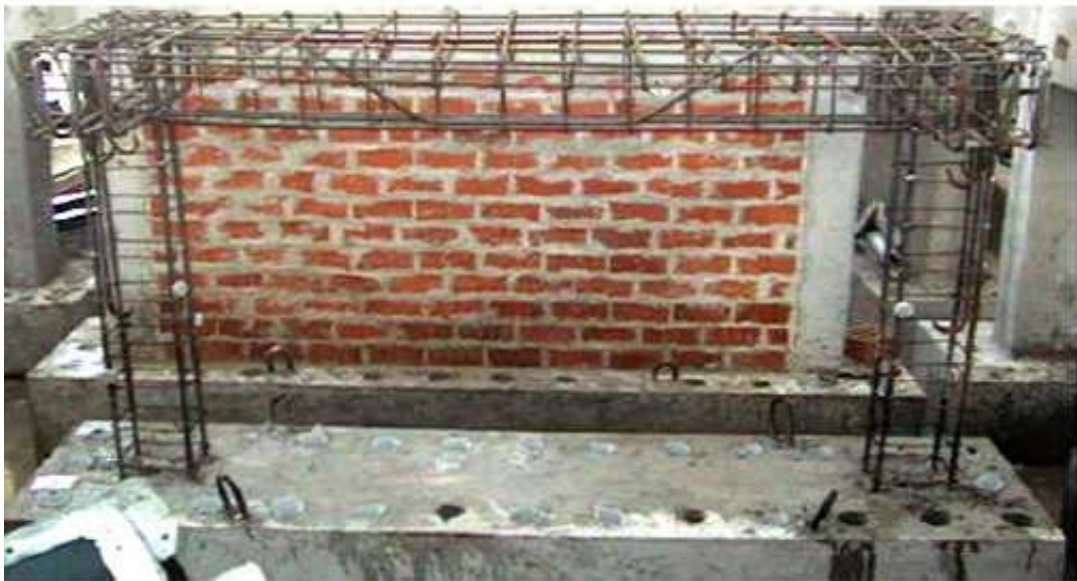
Figure 3.4: The details of frame reinforcement

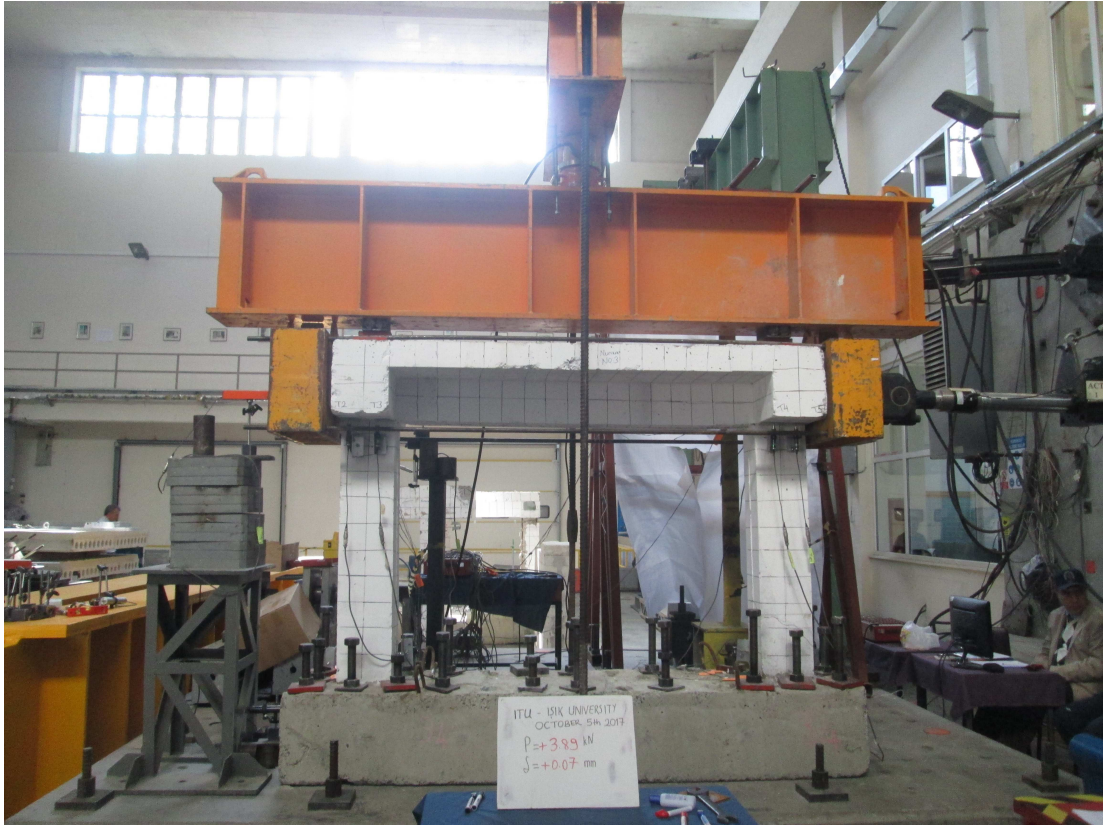
Figure 3.6: General view test setup

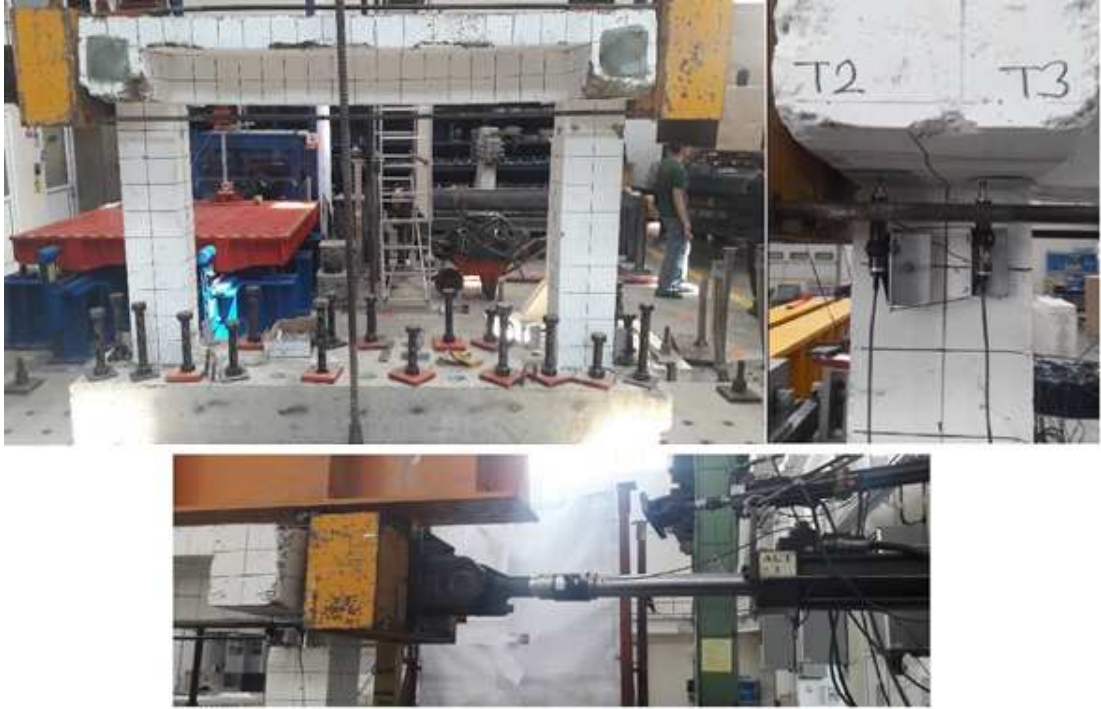
Details of the setup is given in following figure (Figure 3.7).

Figure 3.7: Details of setup

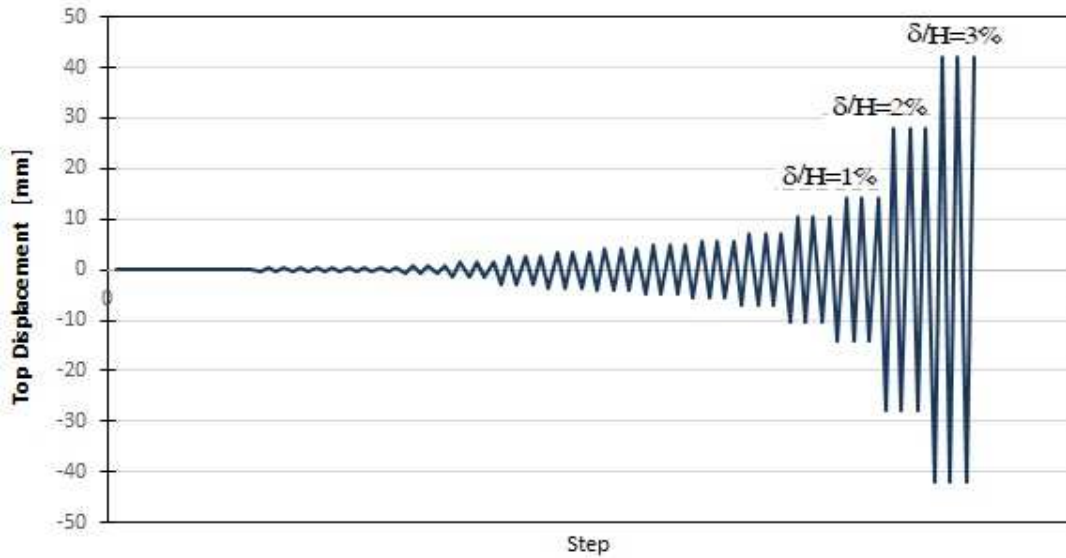
Figure 3.9: Displacement protocol

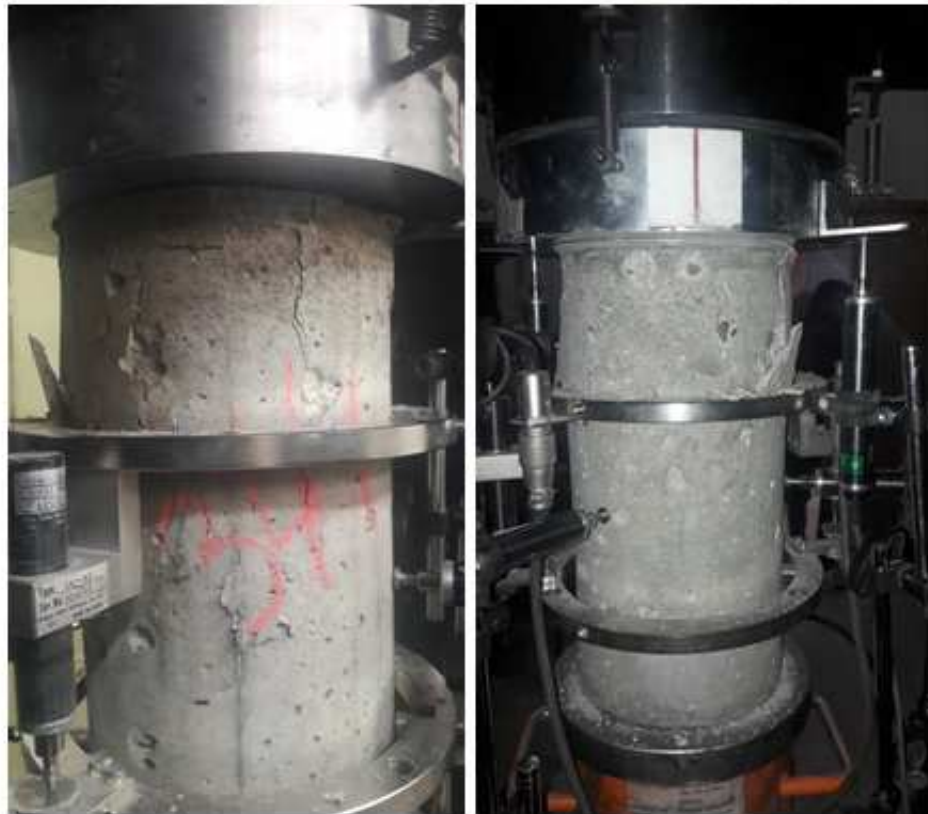
Identical test procedure was carried out for each specimen. Stress-Strain diagrams were obtained for each specimen. The axial stress is computed dividing the load by the net cross sectional area. The axial and horizontal strains are the average of axial and horizontal deformations respectively divided by the specimen length. The compressive test configuration and the deformed view of a specimen are given below (Figure 3.10).

Figure 3.10: Compression test

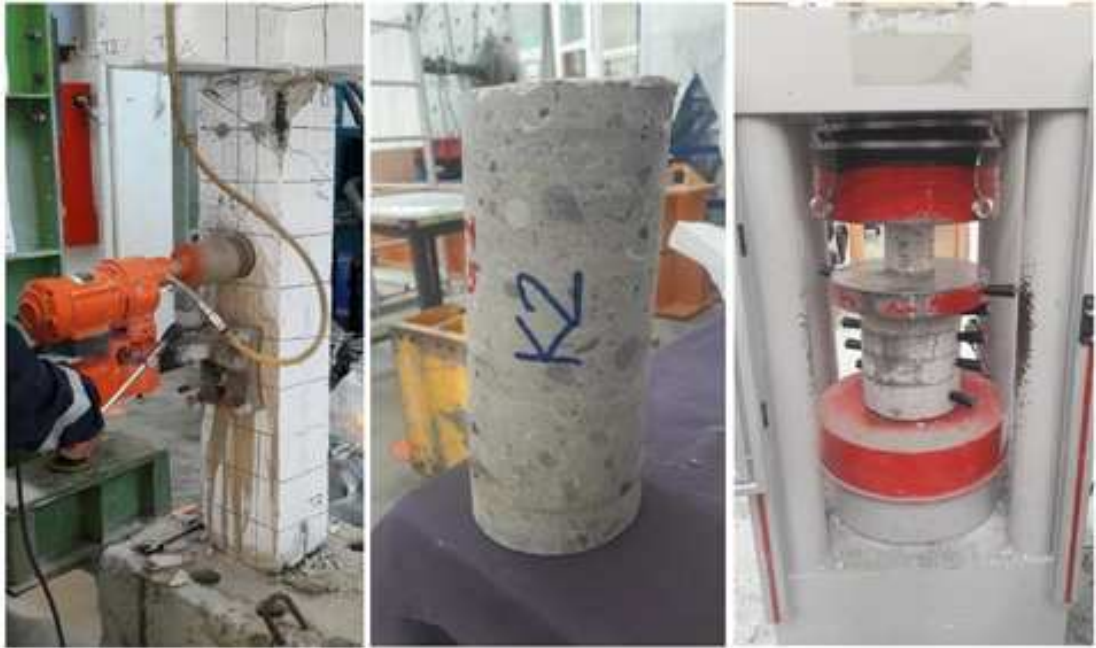
In order to define the mechanical properties of concrete accurately, cylindrical core specimens were taken from columns, beam and slab of the frame. Drilling and testing of the core specimens were performed according to TS EN- 13791 code which specifies the technics for drilling core specimens from hardened concrete, their examination, preparation for compressive test and specification of compressive strength of concrete. After coring, the specimens were tested under compressive force till failure at Construction Materials Laboratory of ITU Civil Engineering Faculty. Details for each core specimen, their compressive strengths and the obtained compressive strength for frame as a result of correlation between compressive test results of core sampling and compressive test results for 15 years old cylinders are given in Figure 3.13. The Figure 3.12 below shows the drilling and testing of core specimen.

Figure 3.12: Drilling and testing of core specimens

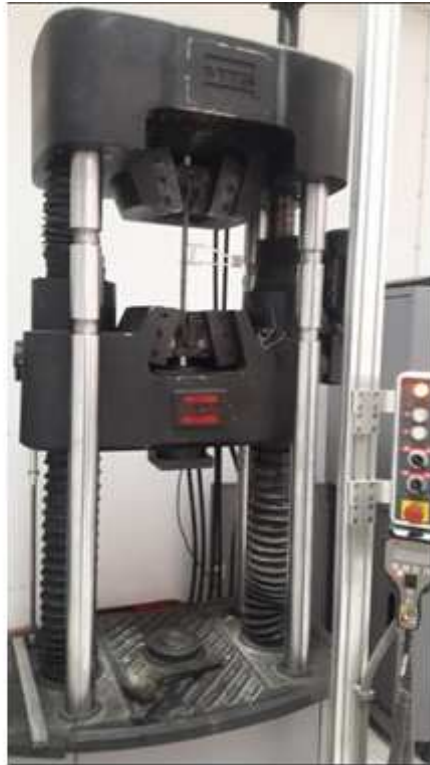
Five longitudinal reinforcing bars that were taken from one column of the frame were cut into eight part totally. Each specimen was tested under increasing tensile force till failure. An extensometer was utilized to obtain the vertical deformation during the tests. The data was recorded using a computerized system of the testing machine. Test set up is given in Figure 3.16 and Figure 3.17. After tests, stress-strain relationship of each specimen derived from the data obtained. Properties of specimens are given in Table 3.4. Tensile properties of the specimens after 15 years given in Table 3.5.

Figure 3.16: Test setup for longitudinal reinforcement

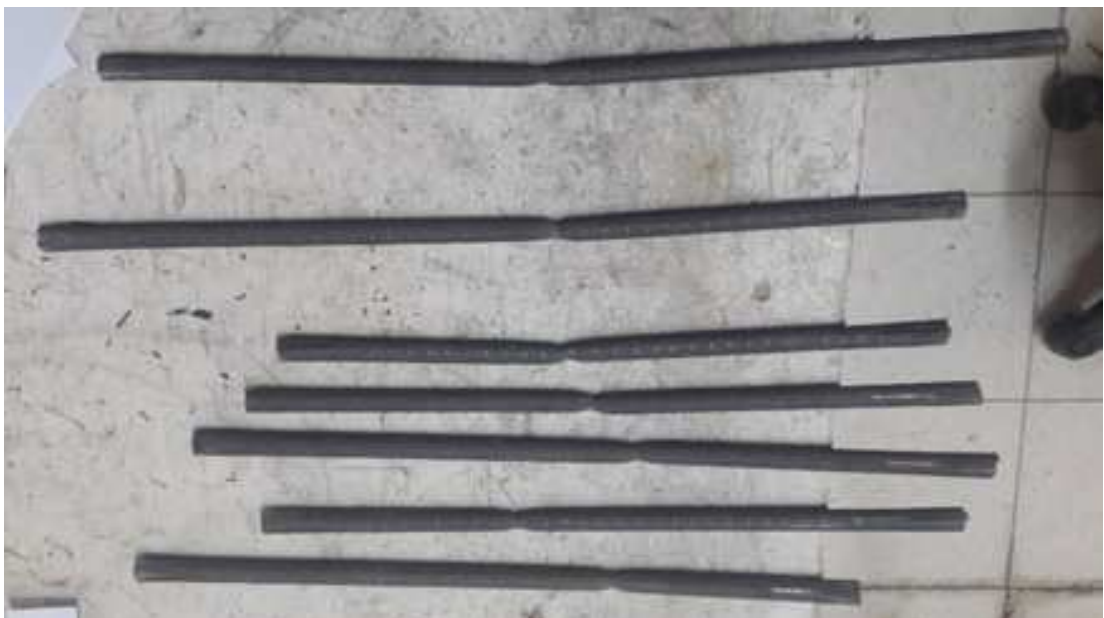
Figure 3.17: Configuration of the steel rebars after tensile test

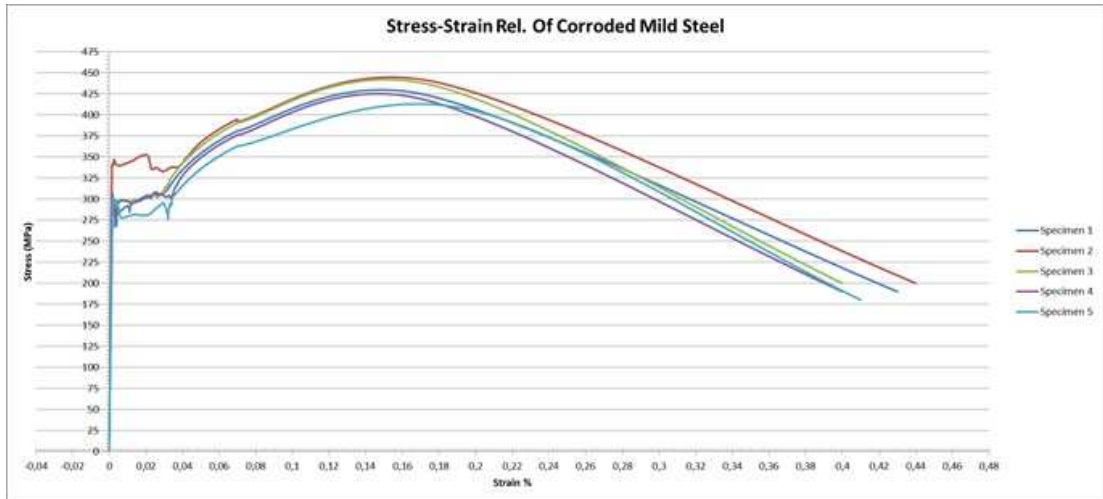
Since the data of three specimens are not clear and proper they were ignored while obtaining the stress-strain relationships. The stress-strain relationships of the five longitudinal reinforcement are given in Figure 3.18:

Figure 3.18: a) Stress-strain rel. of corroded mild steel

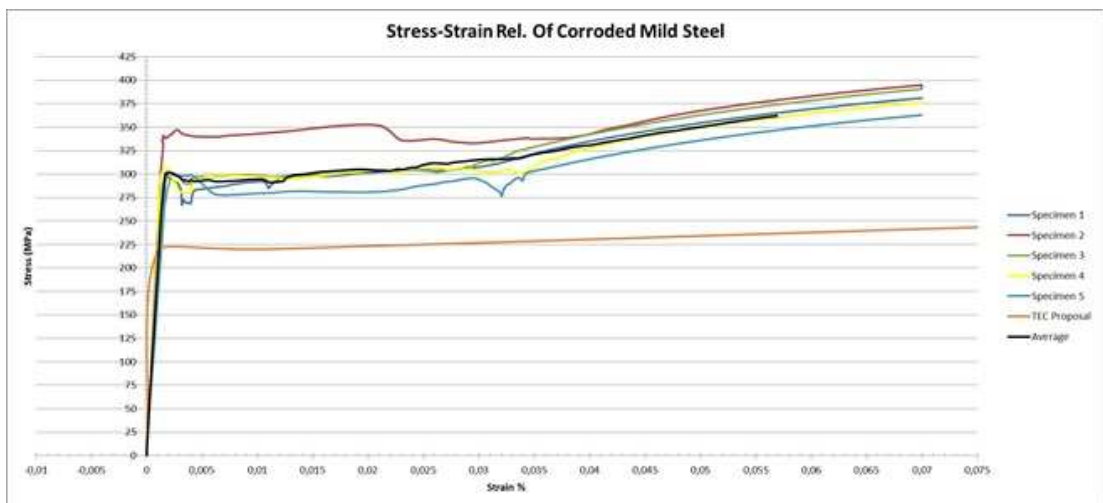
In order to check and control the accuracy stress strain relationship of average of five specimen and the proposal of Turkish Earthquake Code for stress strain relationship of S220 are included in the chart below (Figure 3.19).

Figure 3.19: b) Stress-strain rel. of corroded mild steel

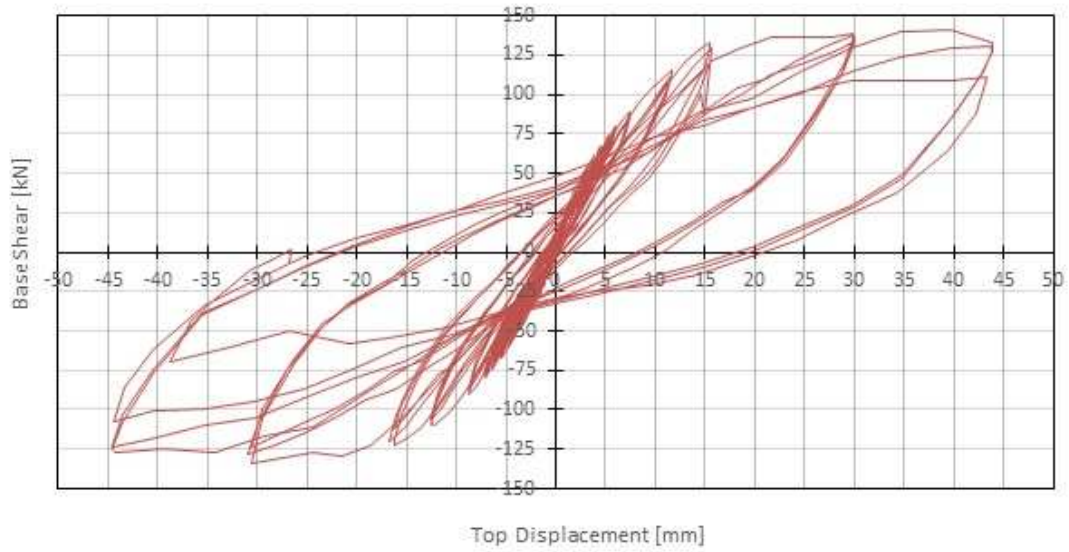
The largest target displacement value applied to specimen was 42 *mm* which corresponds to 4% drift for both pulling and pushing cycles. Base shear force-top displacement curve of the specimen under cyclic loading is presented in Figure 4.1. The ultimate strengths in pushing and pulling are 133.65 *kN* and 128.65 *kN* respectively, which obtained at 3% story drift. The data of envelope curve is calculated as the average of three cycle at each target displacement levels given in Figure 3.8. The envelope curve of base shear top displacement of the 15 years old specimen is given in Figure 4.2.

Figure 4.1: Base shear-top displacement curve of the 15 years old specimen

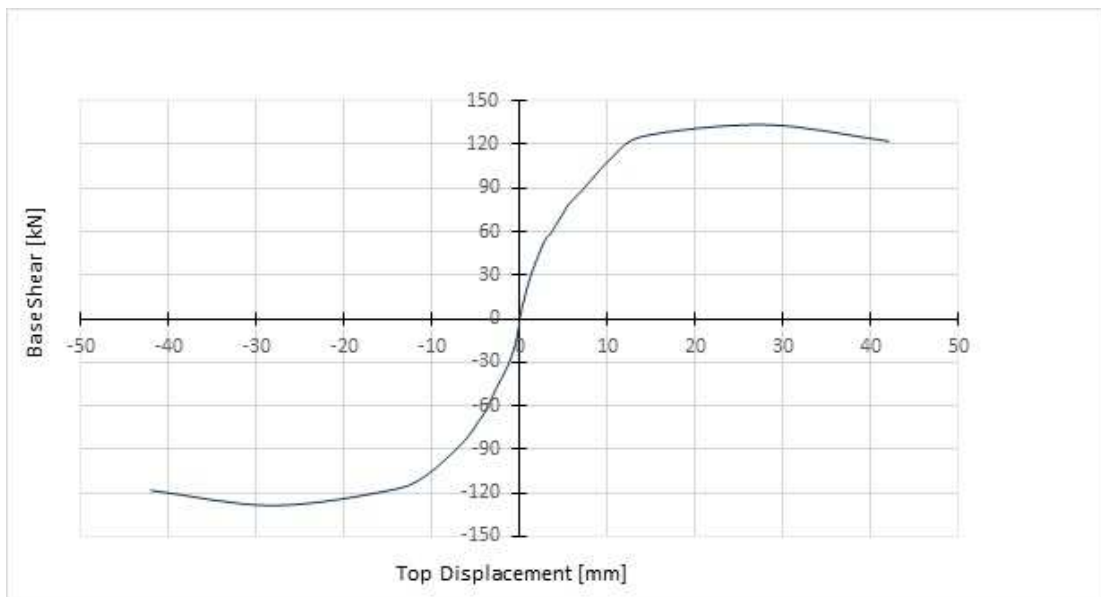
Figure 4.2: Envelop curve of the 15 years old specimen

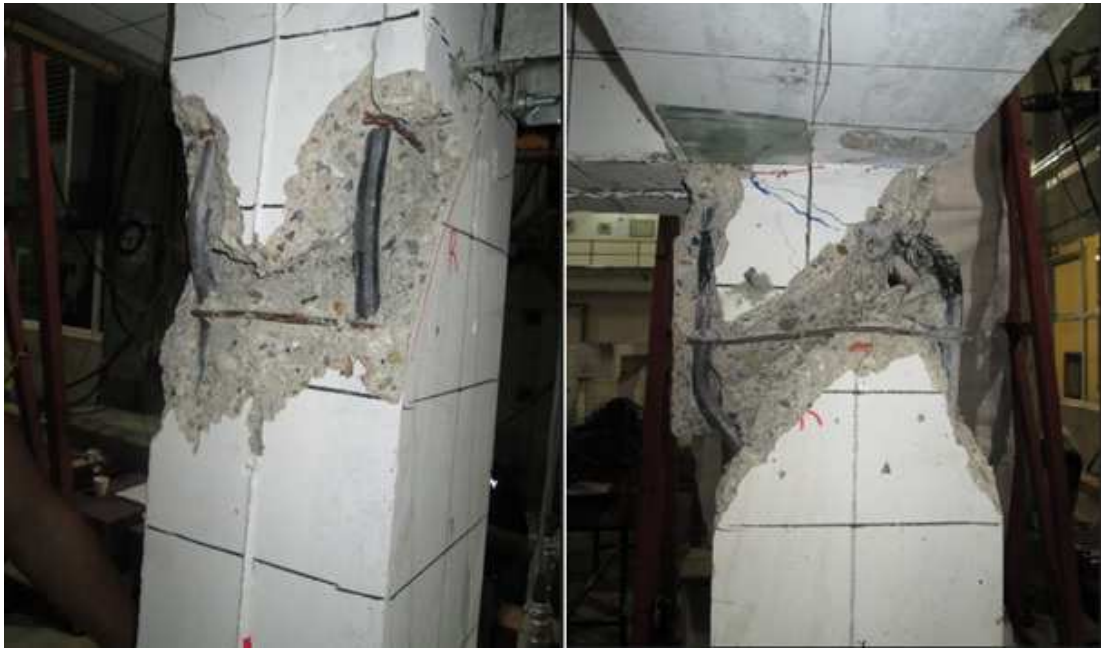
Figure 4.5: Bending and shear failure at right column top end

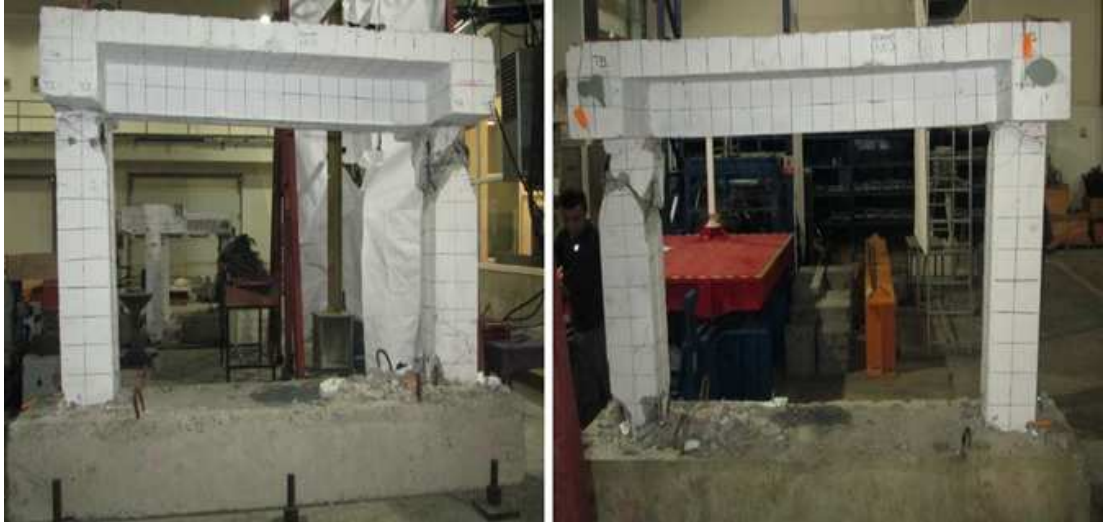
Figure 4.6: Front view and back view of the specimen-A, respectively, at the end of the test

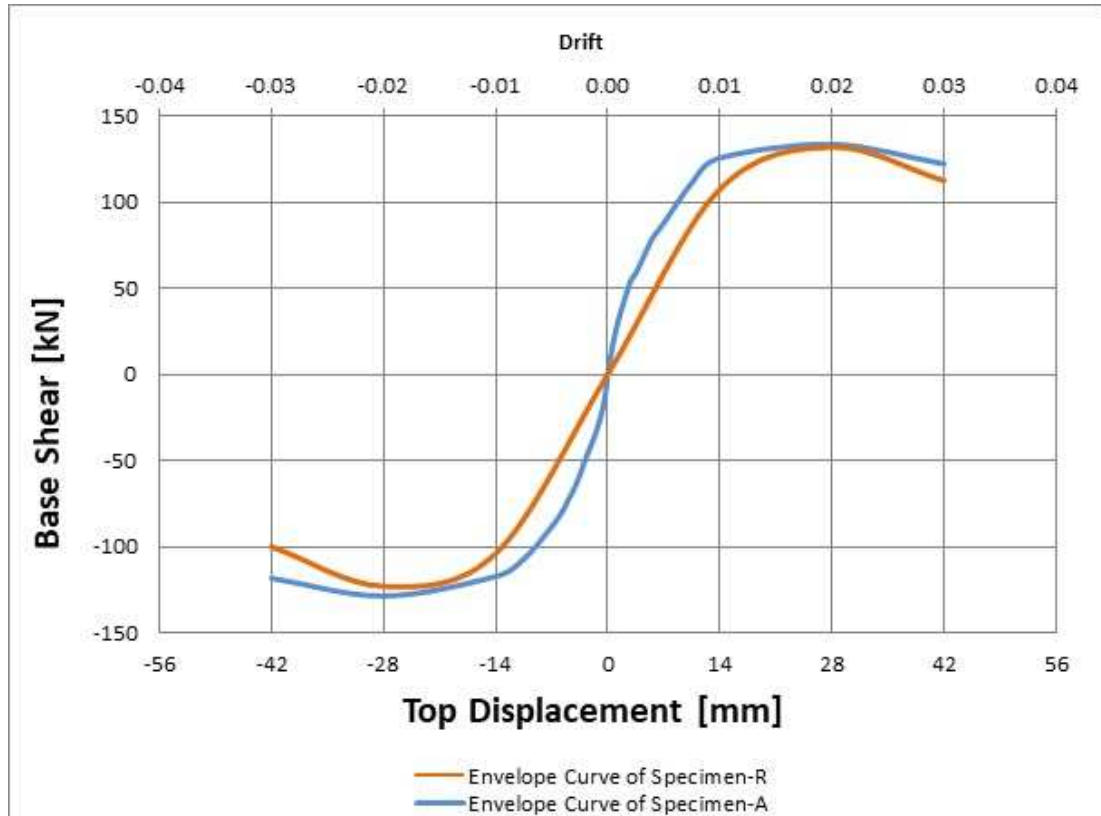
The maximum strengths in pushing and pulling for the specimen-R are 133 kN and 123 kN respectively and for the specimen-A, strengths in pushing and pulling are 133.65 kN and 128.65 kN respectively. Comparison of base shear-top displacement curves of reference frame and actual frame is given in Figure 4.7.

Figure 4.7: The comparison of envelope curves of specimen-A and specimen-R

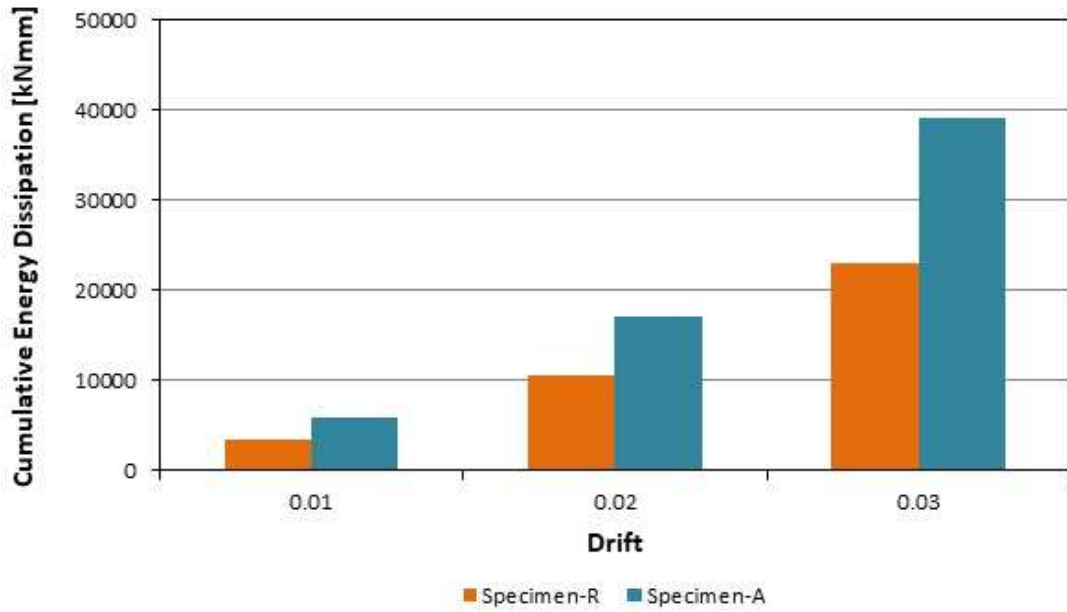
As it is presented in Figure 4.8, the cumulative energy dissipation of the specimen which is the frame tested recently is 2 times higher for 1% drift value than the frame which was tested fifteen years ago. Since Specimen-A has bigger lateral strength and deformation capacity, for 2% and 3% drift, it is almost 1.5 times and 2 times higher respectively.

Figure 4.8: Cumulative energy dissipation capacities at specific story drifts

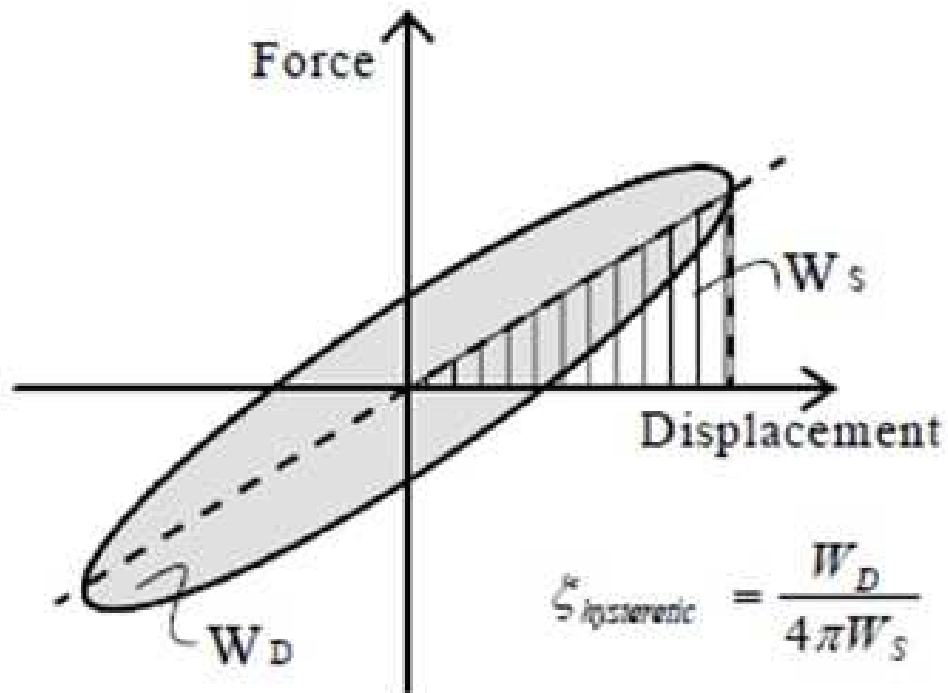
As it was mentioned above 0.05 shows viscous damping ratio. W_D and W_S are points out the energy dissipation in one complete cycle which is corresponding a specific displacement level given in Figure 4.10.

Figure 4.10: Dissipated energy

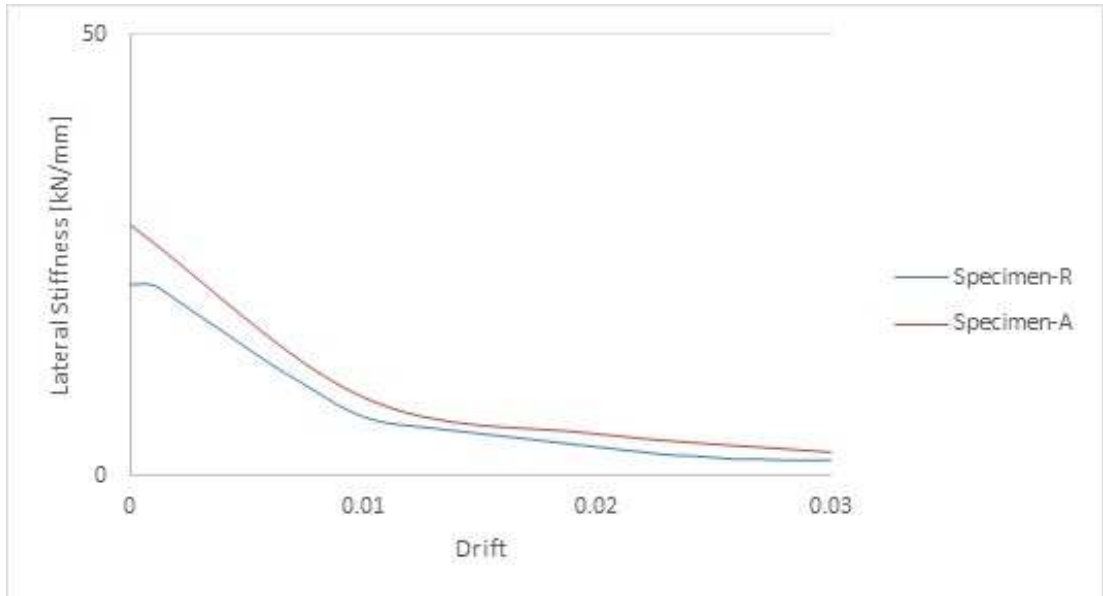
The comparison of the lateral stiffness of specimens according to drift ratios are given in Figure 4.12.

Figure 4.12: Comparison of the lateral stiffness of specimens

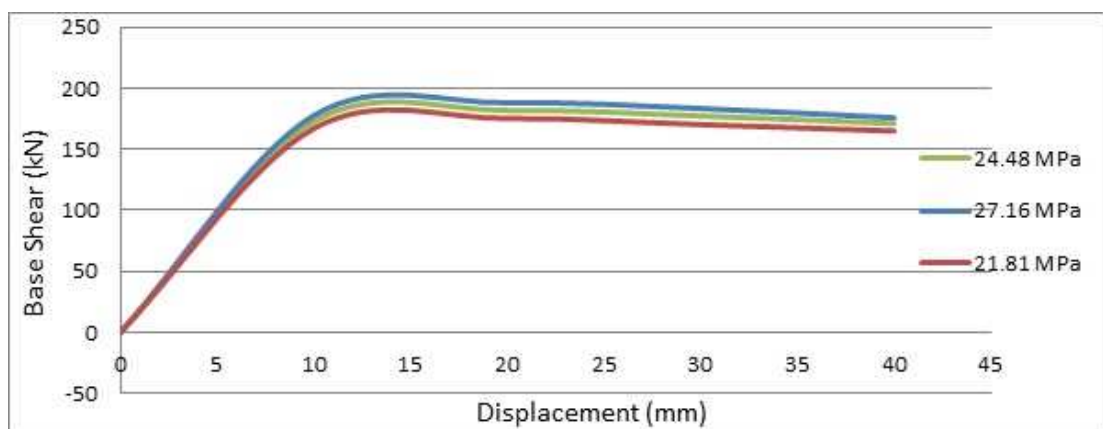
The largest displacement applied to specimen was 42 mm which corresponds to 4% drift for both pulling and pushing cycles. Graphs (Figures 5.4 and 5.5) presented below are envelopes of hysteretic curves for different obtained value of compressive strength of concrete. Elasticity modulus' for each compressive strength value was found according to TS500 proposal and given in Table 3.3.

Figure 5.4: Envelope curves for different compressive strength of concrete

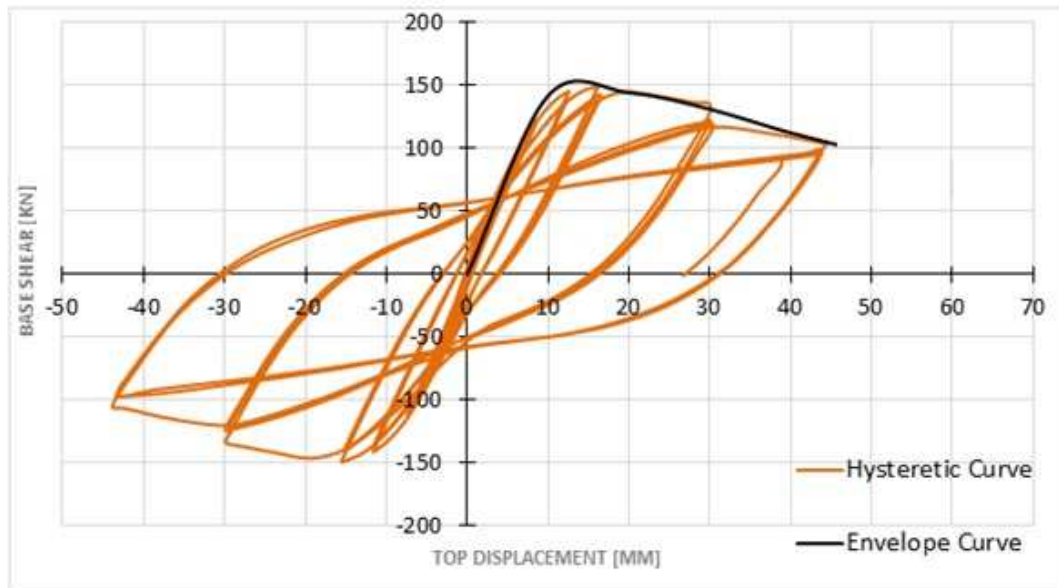
Figure 5.5: Hysteretic and envelope curve for compressive strength of 21.81MPa with different modulus of elasticity of concrete

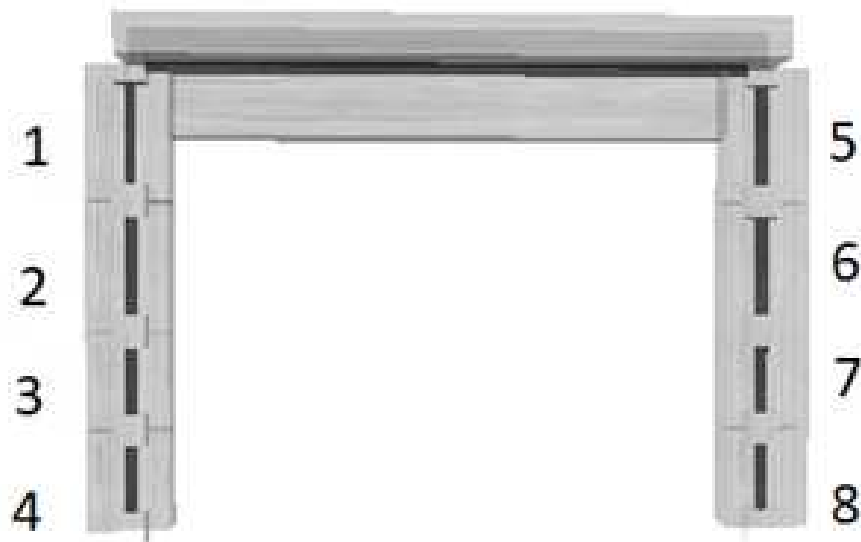
When the nonlinear cyclic analysis is done, SeismoStruct creates a report about damage states of the members. To represent these damage states for the cyclic loading, strain limits were used according to TEC2007 [41]. Figure 5.7 shows the strain limits to obtain damage states of the frame members according to TEC2007 [41]. Figure 5.6 shows how the frame is divided into smaller elements and how these elements are named as numbers to define damage levels separately.

Figure 5.6: Definition of the frame elements in theoretical model used in Seis-
moStruct

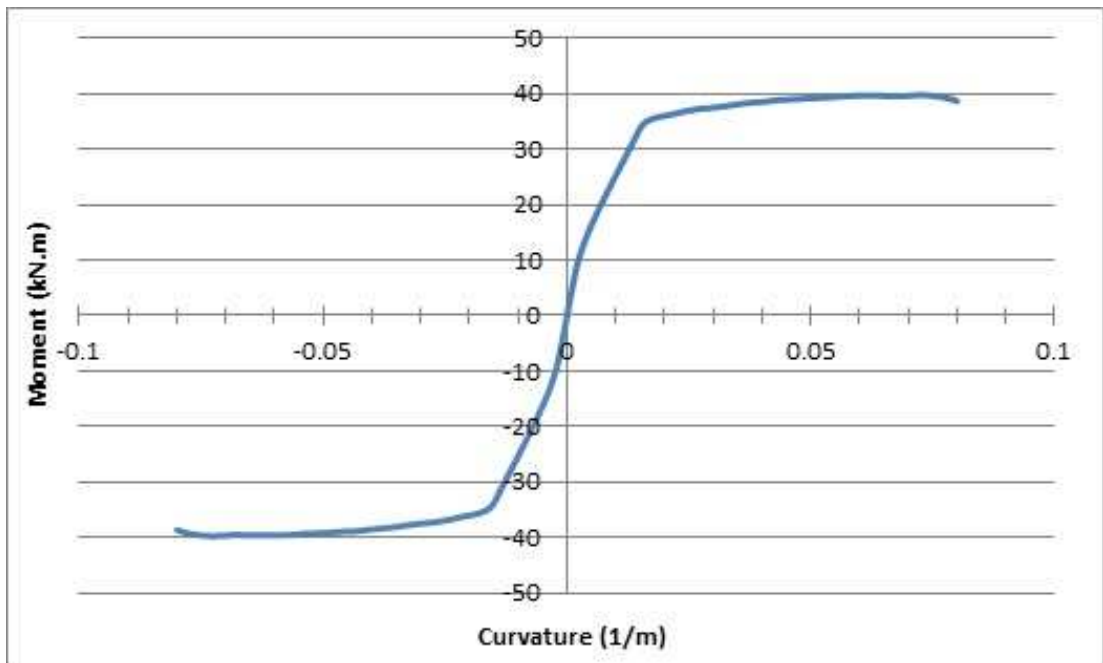
given in Table 5.2 were used to obtain moment-curvature curve of each frame element. Axial force is also considered for columns' moment curvature analysis only. Since columns have two different cross sectional property due to the number and place of longitudinal reinforcing bars at each end, two different moment curvature relationships were obtained for columns. Moment curvature relationship for each member were obtained by XTRACT which is a moment curvature analysis program.

Figure 5.9: Moment-curvature relationship for bottom section of column

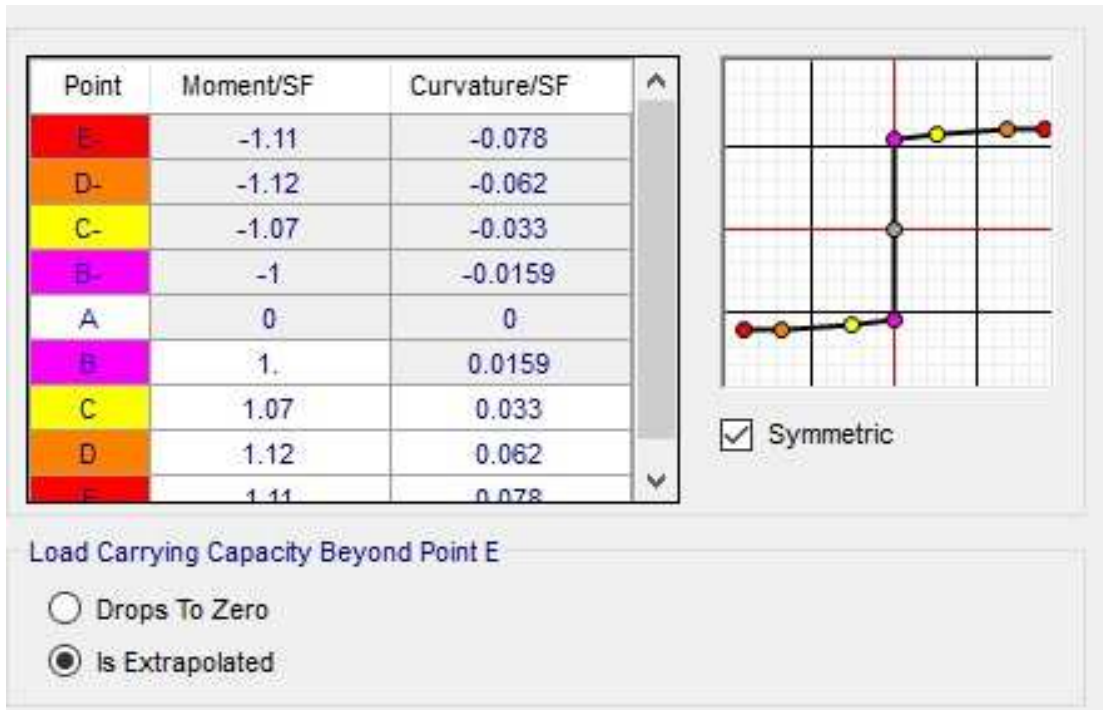
Figure 5.10: Moment-curvature relationship for bottom section of column in SAP2000

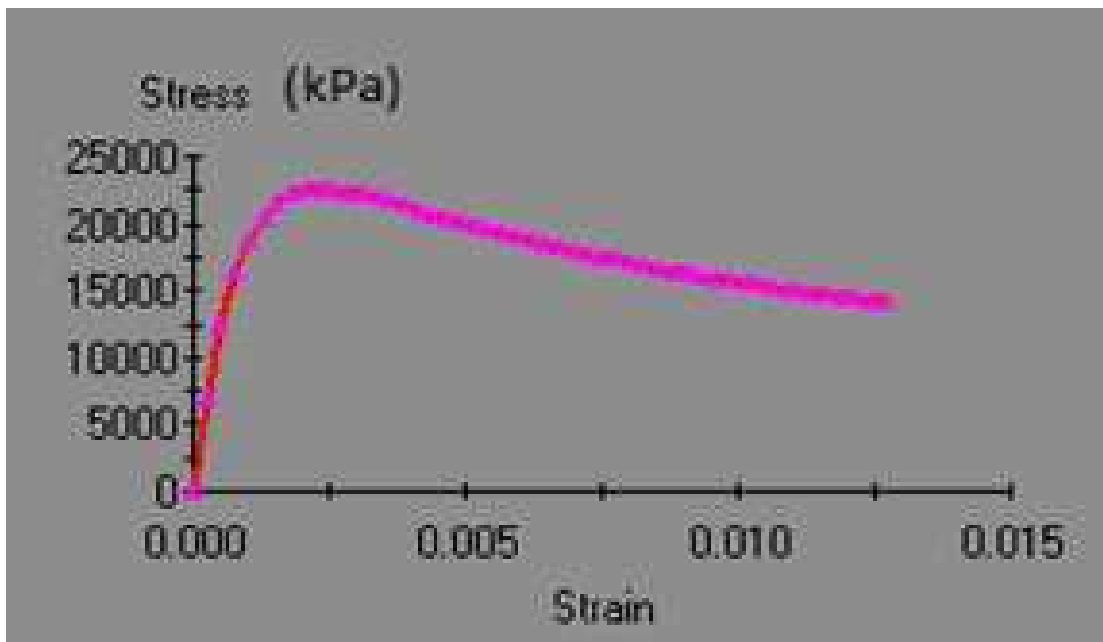
Figure 6.2: Stress-strain relationship of confined concrete

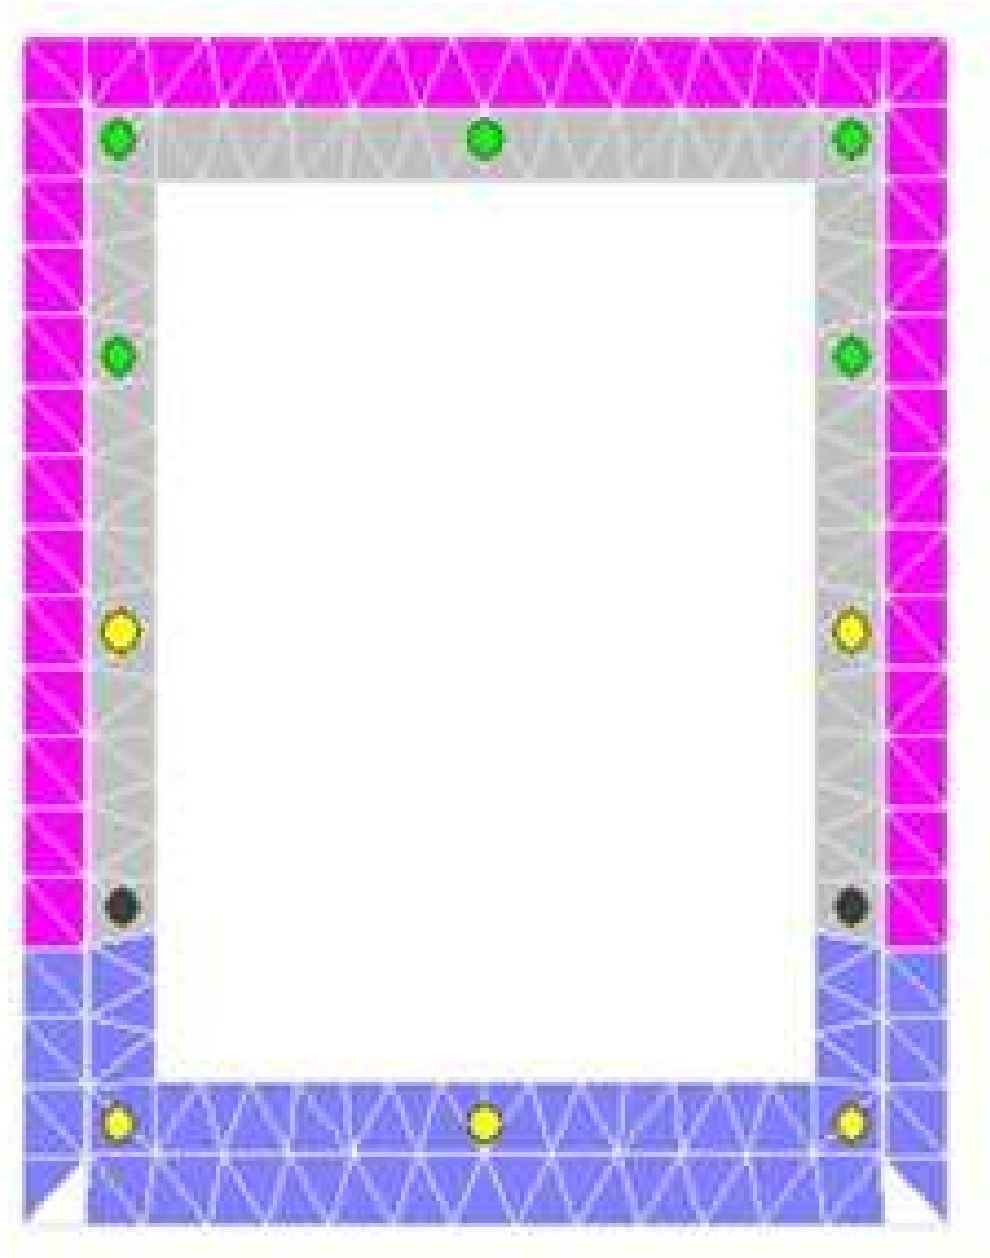
Figure 6.16: State of the section after loading

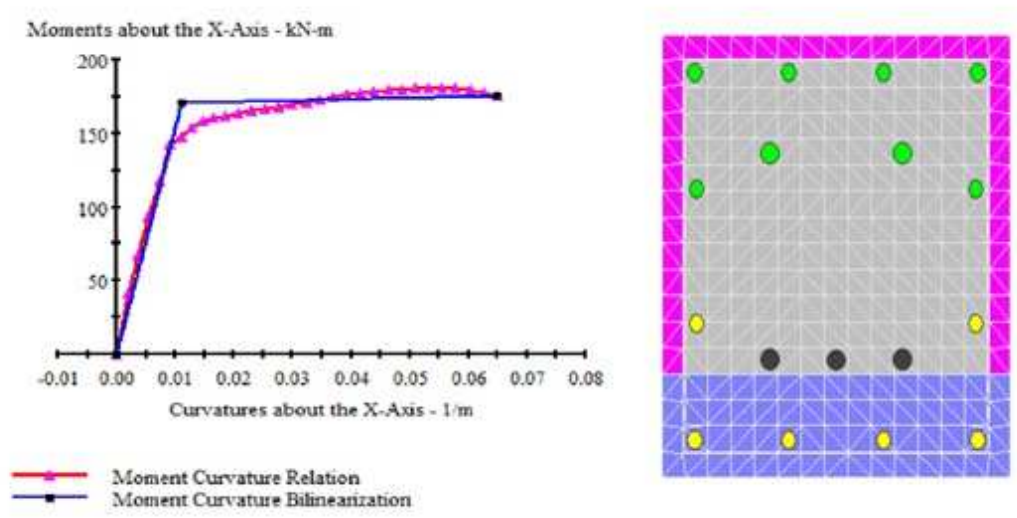
Figure 6.26: Positive moment-curvature relationship of asymmetrically reinforced section and the view of the section after analysis

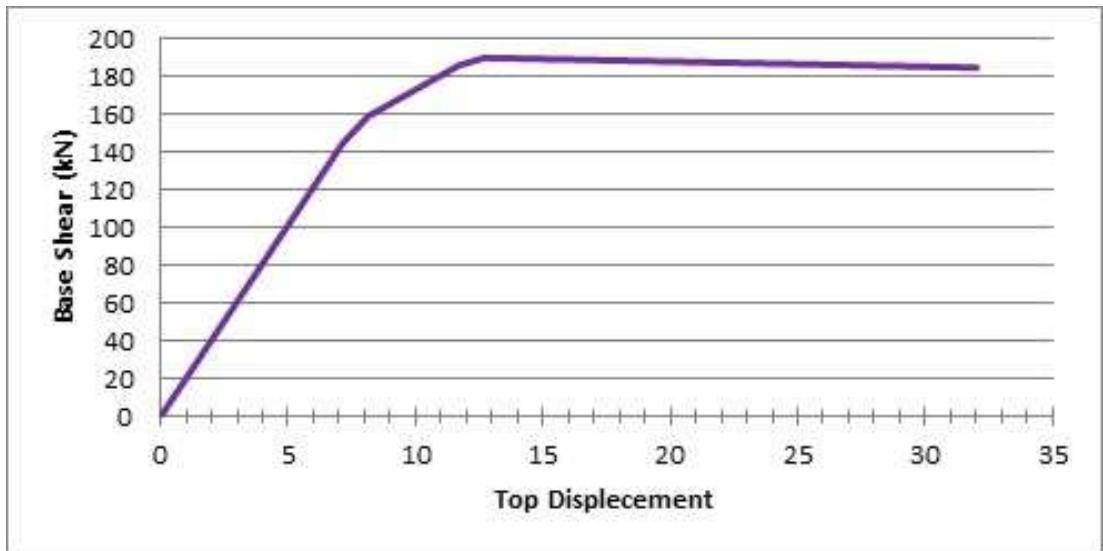
Figure 6.33: Base shear top displacement curve

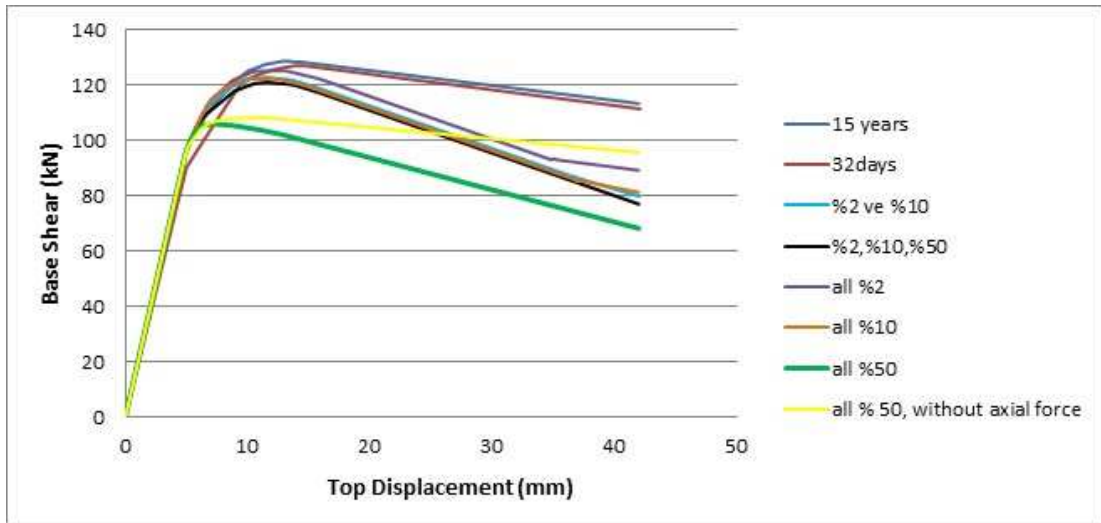
Figure 6.37: Comparison of pushover curves of different amount of corrosion in column reinforcement
