RESEARCH ARTICLE

# Managing health and safety risks in restoration/renovation of historic buildings

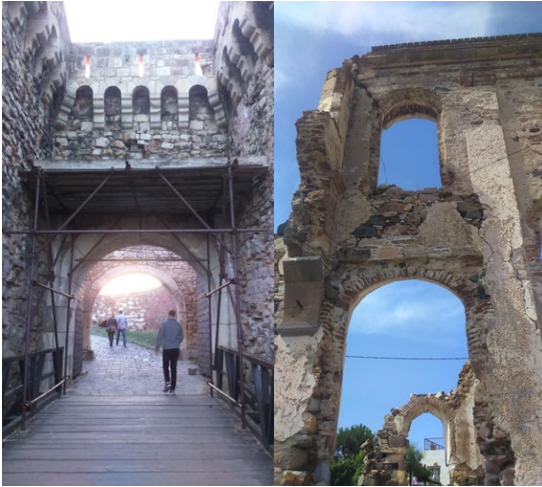
**Fig. 1.** Tourist attracting monumental buildings with and without safety measures during construction phase in Belgrad, Ayvalik. (Photos: Öztürk, D.)

After the commencement of the project, firstly Health and Safety Plan and its annexes (ABSMC Forms) should be reviewed. Project and H&S Coordinator must distribute ABSMC Forms and ensure that those are read, discussed and reviewed by technical staff as well as workers. Construction phase should be performed in accordance with project schedule and H&S Plan. Information to governmental bodies, municipality and other institutions is very important especially for tourist attracting historic buildings and those of in downtowns. Site boundaries passageways, traffic routes must be indicated and necessary health and safety measures for public safety should be ensured (see Fig.1).

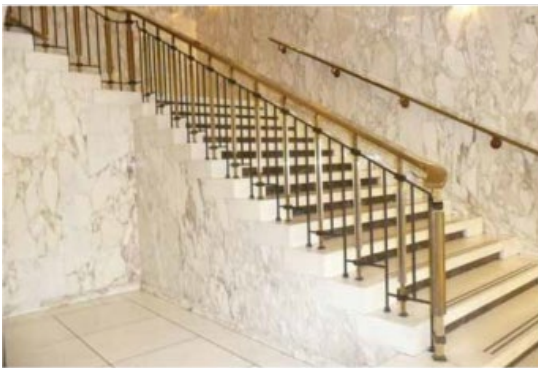
**Fig. 2.** The balustrade at the National Archives and Library in Ottawa underwent a sensitive rehabilitation to meet current requirements for spacing between balusters. (Provincial, 2014.)

- Historic buildings have health and safety risks before the construction,
- Historic buildings have additional and specific health and safety risks during the construction,
- Historic buildings continue to serve their functions and may be used during restoration,
- Historic buildings may change their functions, transformed into a new one after restoration (from old fire station to museum),
- Finally, historic buildings do not meet current health, safety and fire (HSF) regulations due to lack of or insufficient HSF regulations when they built. An example for this issue can be seen in Fig. 2. that shows changed guardrail regulations.

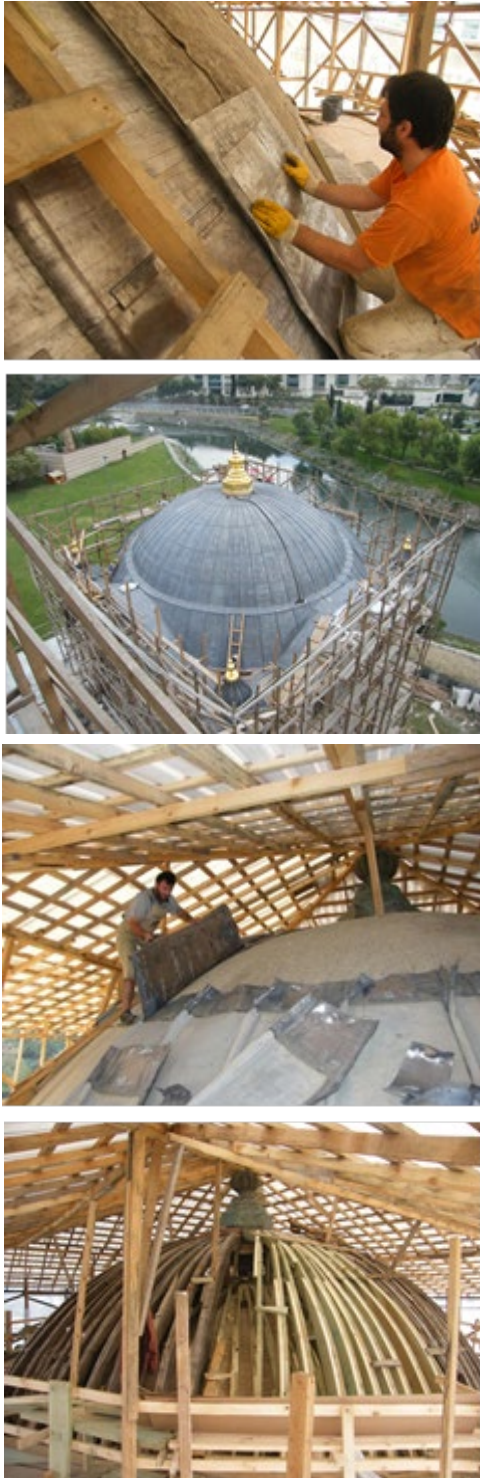
Fig. 4. Restoration activities for the dome of the Sadabad Mosque (Photos: Öztürk, D.)

In the scope of this paper, restoration project of Sadabad Mosque is given as an example to show different aspects, difficulties and risks during the restoration project and how health and safety practices should be implemented. Sadabad Mosque built on the shores of Kağithane stream in 1722 and damaged twice by fire and it was last rebuilt in 1862. The designers of this peculiar mosque were the architects Sarkis and Agop Balyan (See Fig 4.).

The mosque influenced by baroque style, walls were built of masonry wall, interior dome and altar were adorned floral decorations and covered externally by lead sheets. Between 1997 and 1998 it was largely restored to its original state but in last years the mosque required new restoration works between the years of 2012 and 2014. An occupational safety specialist and an occupational physician are involved in the restoration project and follow the local legal requirements in Turkey. Although there are some basic plans and procedures related to OHS in the project, it has been observed that there are no hazard and risk assessment procedures specific to restoration works. The restoration site could be followed throughout the entire process and investigated some basic restoration items such as drainage, strengthening of the masonry walls, restore of the dome structure, renewal of lead coating, conservation of baroque motifs in inner dome and altar, cleaning of the facade stones.
